Case Study – Investigating Failures on a 900mm GRP Rising Main

AESL investigated three failures of a 900mm diameter GRP rising main that occurred over a three-month period. The main, constructed between 1997 and 2000, operates at 2bar and is around 6.7km long, with a 4.7km long buried GRP section, the remainder being above ground steel. The main has ten air valves fitted, two combined gas release and air ingress valves, and the remainder gas release only.

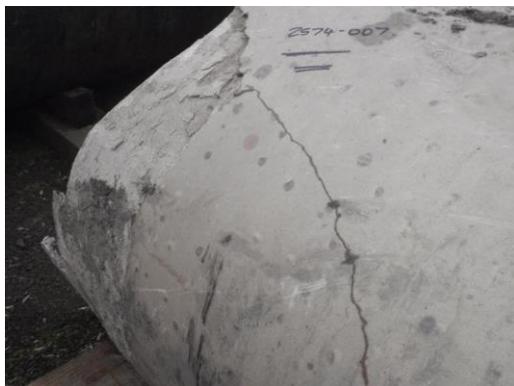
The three failures involved longitudinal fractures, which in two cases, were seen to have initiated from external cracking associated with GRP delamination. Potential causes of localised GRP pipe wall deterioration were investigated and eliminated:

- Strain corrosion can result from low pH (acidic) surrounding soils, but the pH levels from in situ testing were too high to cause strain corrosion.

Longitudinal cracking of GRP pipe

- Star cracking indicating impact damage was not found.
- A maximum ovality of 0.4% measured on the failed pipe samples, indicates no significant permanent deformation

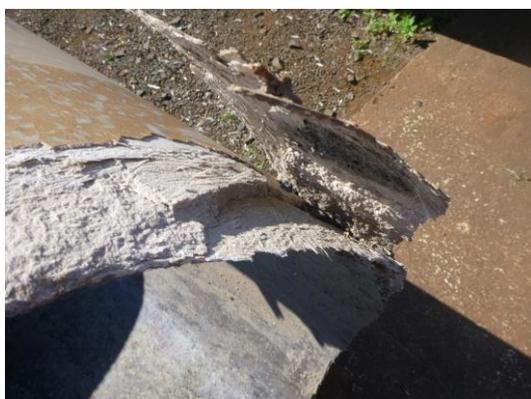
Both the failed pipeline sections and the mechanically tested samples showed external star cracking defects. On the failed pipeline this was considered to indicate pipe wall delamination, possibly due to low internal pipe pressures during surge events. Together with the propagation of the fractures, this suggested that high dynamic loading due to inoperative air valves may have contributed to the pipeline failures. Each of the air valves were inspected and only two were found to be operating.

GRP pipe wall delamination

A programme of air valve maintenance was then carried out, following which no failures have occurred.
