Case Study – Pipe Joint Monitoring During Leak Repair

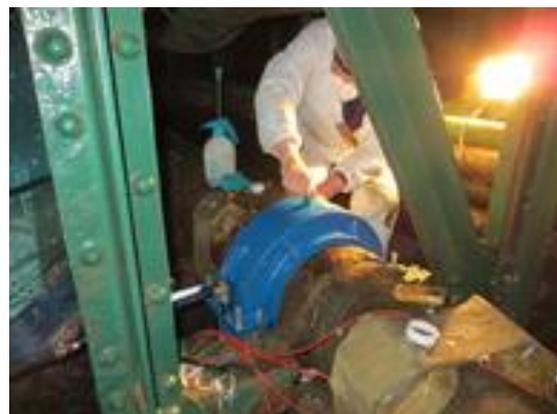
leak clamp being fitted

The wrap around steel leak clamps were designed to seal against the pipe wall and fully enclose the leaking joints, and were to be installed with the pipeline operating. However, in order to fit the leak clamps, the pipe to bridge restraint structures would need to be temporarily removed. Removing this restraint was not considered acceptable unless it could be confirmed that no significant pipeline movement would result. Such pipeline movement could occur if the sliding joints were not functioning and the bridge movement was stressing the pipeline.

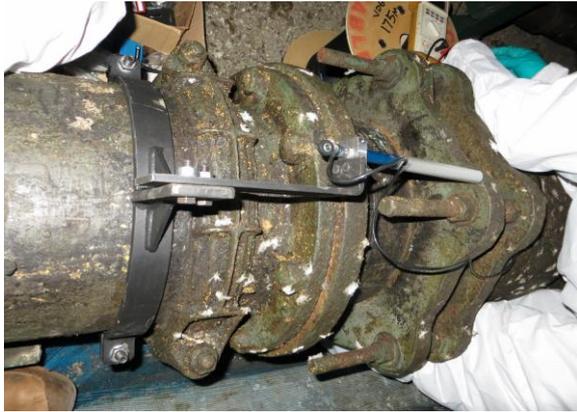
Linear transducer on sliding pipe joint

Thus monitoring instruments were installed, vibrating wire strain gauges on the pipelines close to the leaking joints, linear movement transducers at the sliding joints, and pipe wall and ambient temperature measurement. This data was recorded at the bridge over a two-month period, and automatically transferred by mobile phone to the AESL offices daily for analysis. The limited sliding joint movement for the temperature variation recorded indicated that the sliding joints required adjusting to provide more longitudinal freedom, and two joints were freed accordingly. The strain gauges were then monitored as the pipe to bridge restraint was temporarily removed.

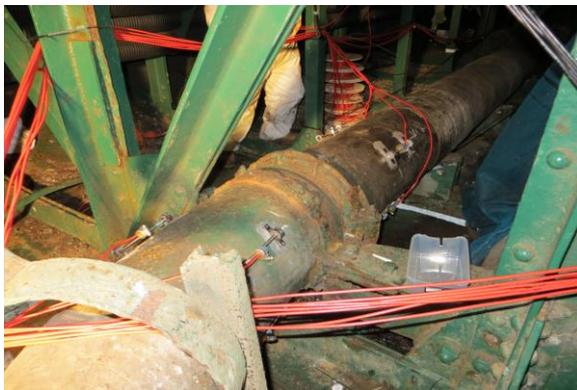
Vibrating wire strain gauges either side of joint
