Case Study – Rehabilitation of Wrought Iron Pipe Bridge

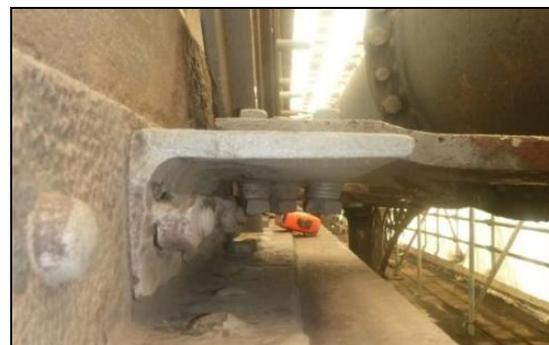
The AESL bridge inspection revealed that 35 brackets which support the pipeline along the length of the bridge were severely corroded and some were sagging, these required replacement.

*Fig 2 - Corroded and sagging brackets
(35 brackets required replacement)*

Temporary supports were designed and manufactured to allow the replacement of the brackets to take place safely and without compromising the integrity of the pipe.

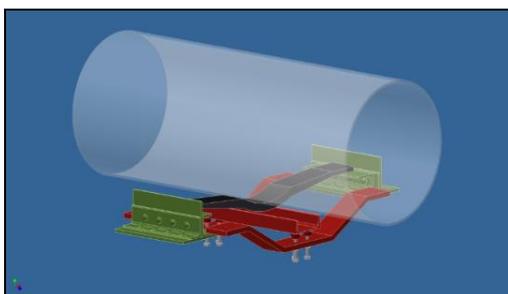
Fig 3 - Temporary support during bracket replacement

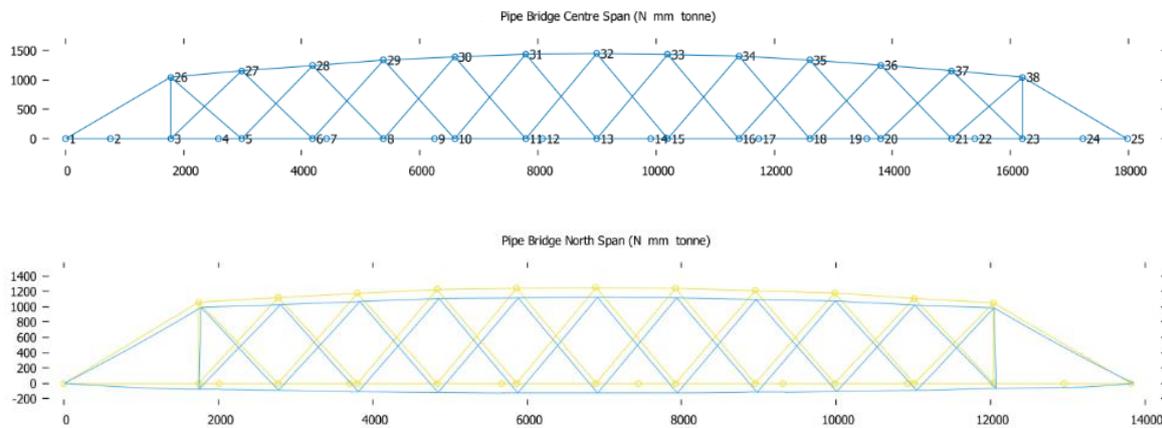
AESL completed a stress analysis of the corroded pipe bridge to confirm whether the bridge structure was within the allowable stresses for the wrought iron material and whether reinforcement of the corroded sections was required.

Fig4 - Stress analysis of Pipe Bridge - deflected structure (bottom diagram)

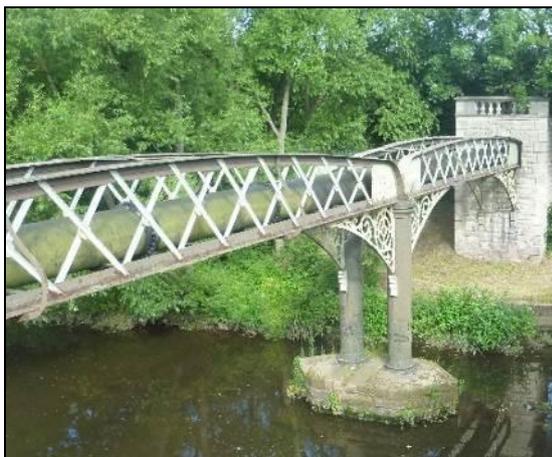
Fig4 - Before refurbishment work

Repairs were made to secure the ornamental lattice work on the bridge. Finally AESL grid-blasted and re-painted the metal structure of the bridge and pipework.

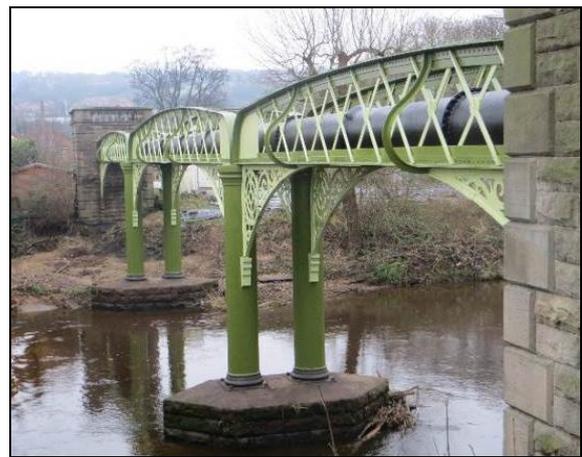
Fig 5 - After refurbishment work
