Case Study - Failure of Ductile Iron Sewer Rising Main

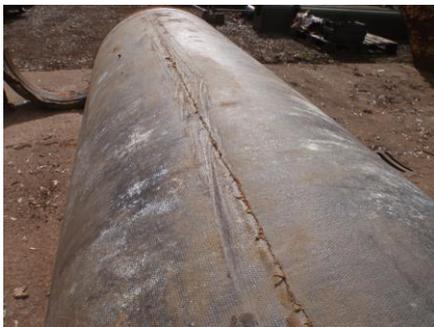
Three failures occurred in close proximity on a 700mm diameter ductile iron sewer rising main, the third failed pipe section was delivered to AESL for failure investigation. A fracture along top dead centre ran the majority of the length of the pipe spool (Fig 1), this was reported to be the same type of fracture as on the first two failures.

Fig 1 - External pipe surface along line of fracture

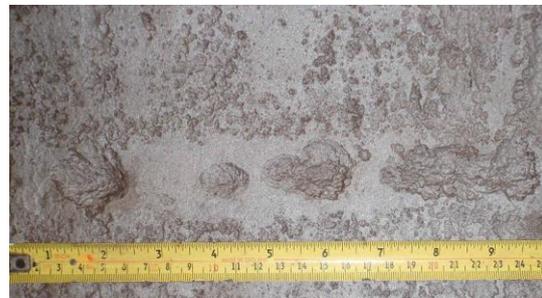
A section of the pipe wall was removed for detailed inspection. Deep corrosion pitting was identified along the line of the fracture on the internal surface. This line of corrosion was observed to be extremely localised (approx. 30mm wide) and ran in a straight line along top dead centre of the main. This pipe section was grit blasted to remove any corrosion product and allow accurate measurement of the depth of corrosion. (Fig 2)

Fig 2 - Close up of line of internal corrosion post grit blasting

Inspection of the socket from the adjacent pipe spool confirmed that the line of corrosion continued on the adjacent pipe spool suggesting that the pipe wall corrosion occurred after the main was laid.

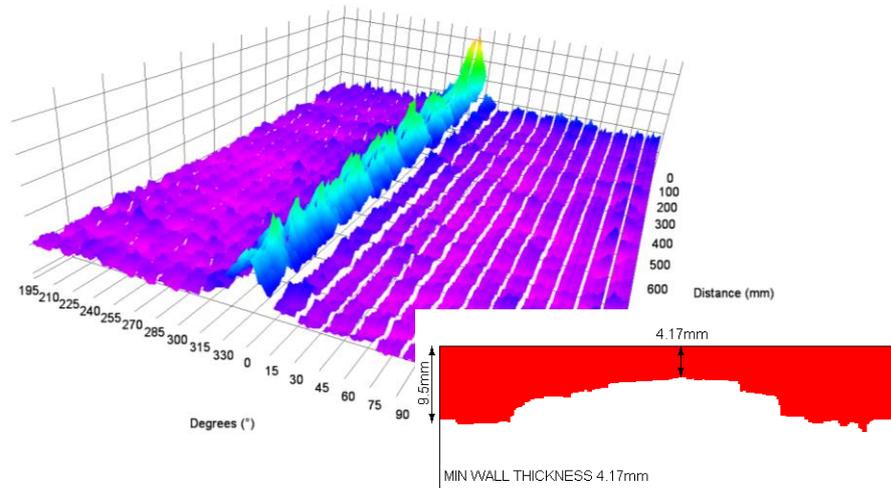
The inspection method was testing on the failed pipe spool to ensure clear results were achievable (Fig 3). The line of pitting defects were clearly visible at 0° on the MFL data and B-scan ultrasonic data showed a wall thickness reduction from 9.5mm to 4.17mm.

Fig 3 - MFL inspection and B' Scan Ultrasonic results on fractured pipe showing significant localised wall thickness loss at 0° (crown of pipe)

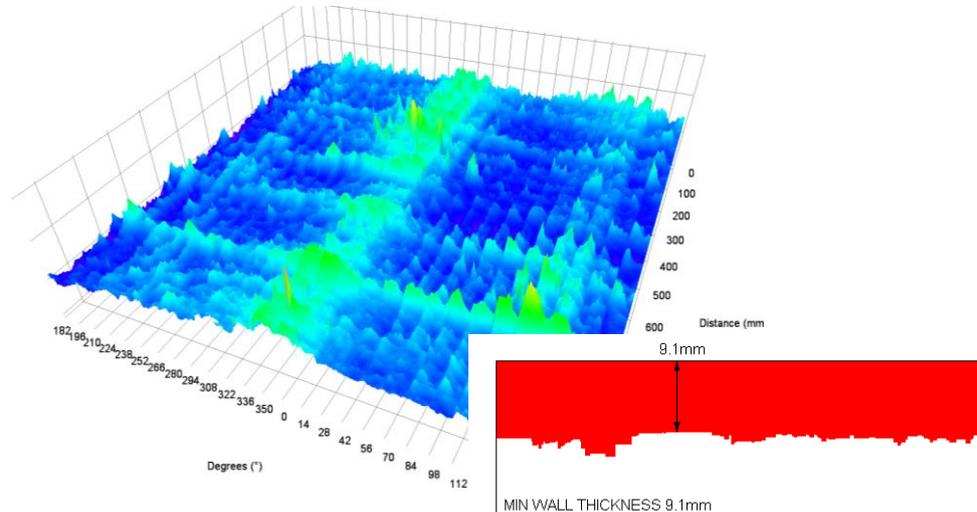
Inspection locations on the live pipeline were located along the rising main each location representing a section of the pipelines length. Fig 4 shows the results of the inspection closest to the failure, 250 metres up stream. The MFL data clearly shows that the pattern of wall thinning at 0° exists at this location, however the magnitude of the response is much smaller. B-scan results measured a minimum wall thickness of 9.1mm on a general wall thickness of 10.7mm.

Fig 4 - MFL inspection and B Scan Ultrasonic Inspection showing wall thickness loss 250metres upstream of the failure

The pattern of corrosion that had caused the failure was evident at other locations on the pipeline, but to a much lesser extent. However given the short time over which the corrosion had developed, the remaining life of each section effected was severely limited.

The customer was able to use the inspection results and life prediction to plan a remediation strategy, focusing first on the the sections most effected by the pattern of corrosion .
