PIPE COATING WORKS

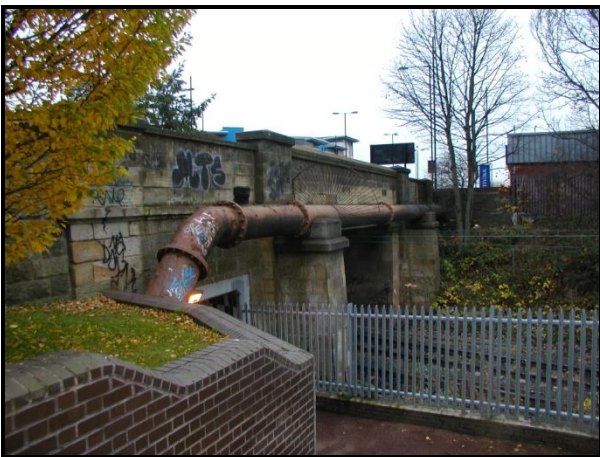
Original Pipe Crossing

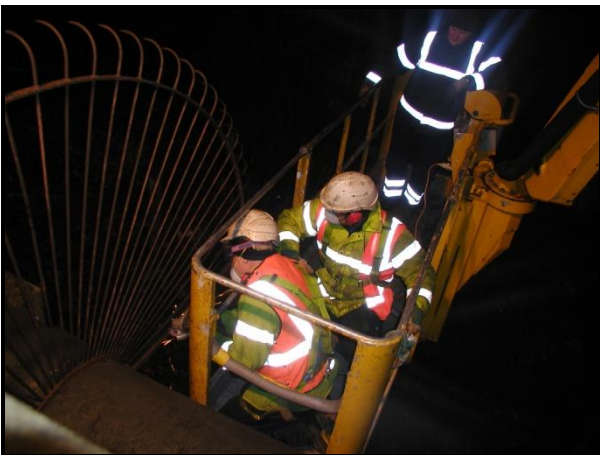
Removal of anti-vandal Guards

The Company has recently completed the refurbishment of a pipe crossing over a metro line for Northumbria Water Limited. The works involved the removal and re-installation of two sets of anti-vandal guards following grit blasting and re-painting with the Denso Epoxy/Polyurethane corrosion protection system. The pipes sections were power wire brushed and then wrapped using Denso Hi-Tack Tape followed by Denso Ultraseal Tape and finally coated with an acrylic paint system to seal and further protect, all joints were profiled using Denso profiling mastic to accommodate wrapping.

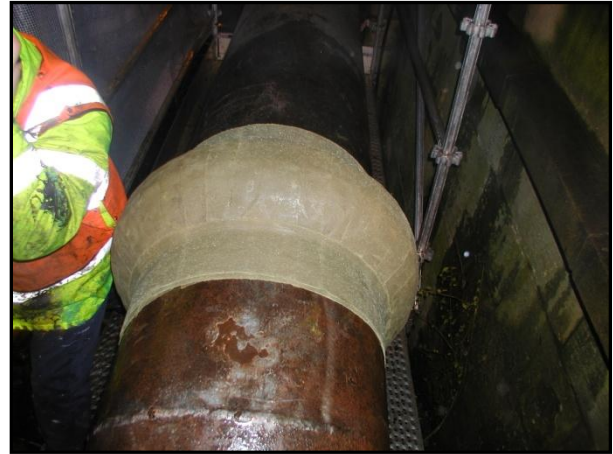
Pipe joint profiled and wrapped

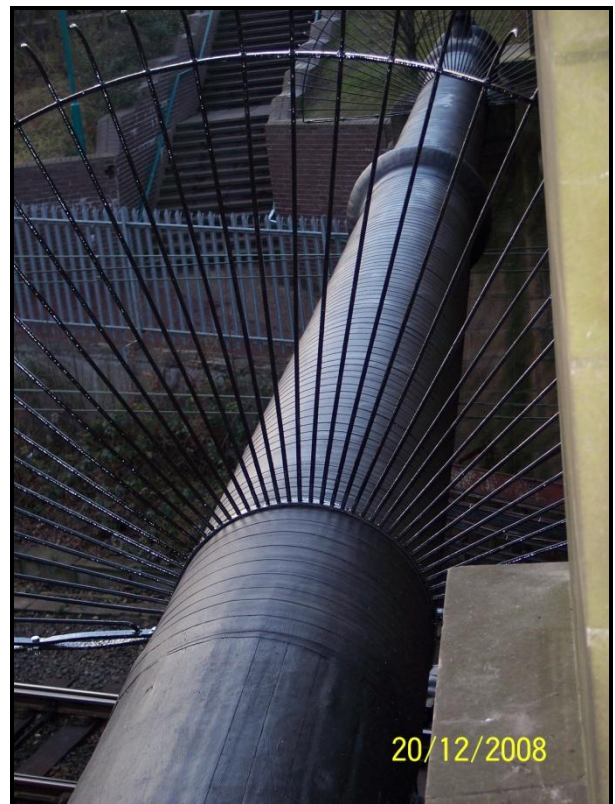
Completed Works

The works took 6 nights to complete working between 1.30am and 3.30am, work was conducted over the bridge parapet using an access platform and at each end of the pipe crossing from a scaffold working platform. The works required full traffic management to allow the access platform to be sited and that the track and overhead power be isolated during the working period.
