Case Study – Rehabilitation of Wrought Iron Pipe Bridge

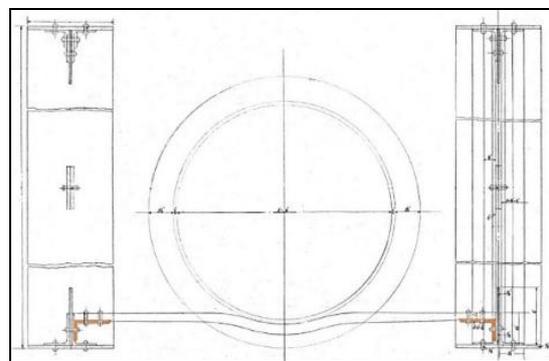
Fig 1 - Cross sectional drawing of Pipe Bridge

The AESL bridge inspection revealed that 35 brackets which support the pipeline along the length of the bridge were severely corroded and some were sagging, these required replacement.

AESL inspected, analysed, repaired and refurbished the three span wrought iron bridge of bolted and riveted construction and the 30inch diameter wrought iron riveted pipeline to restore the integrity of both the bridge and the pipeline.
