Non-Intrusive Pipe Inspection

Defect Characterisation

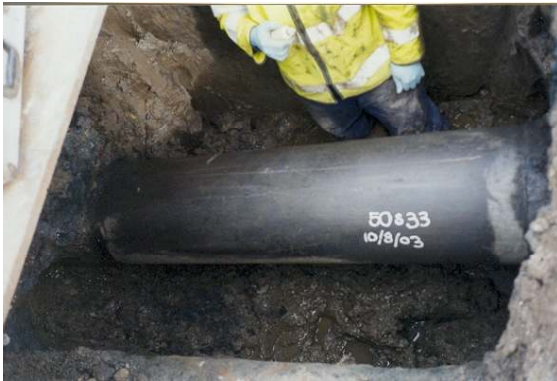
Photograph 1 - Pre-scanned Pipe

Photograph 1 above shows a pipe which was assessed using the AESL condition assessment tool. Visually the pipe appeared to be in good condition. Scans from the tool were downloaded to AESL-developed software, allowing sensor outputs to be plotted against pipe length.

Photograph 2 below shows the identified external defect in what was otherwise thought to be a clean and sound pipe as seen in Photograph 1.

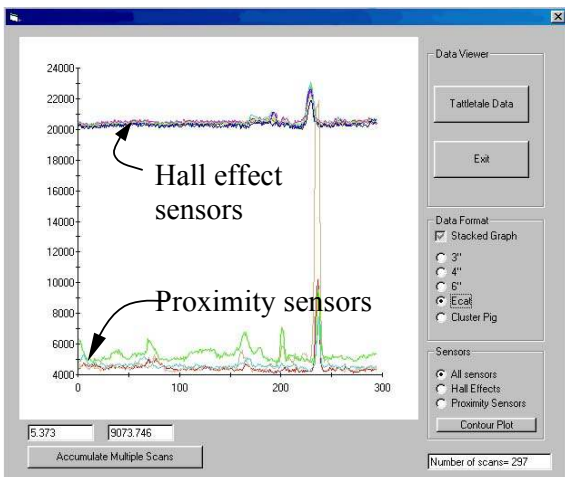
Figure 1 - Sensor Output Traces

Metal loss and defect characterisation is determined using two types of sensor. These sensors differentiate between overall metal loss and external metal loss. By analysing the two sensor outputs together it is possible to differentiate between internal and external defects

Figure 1 above shows readings from both sensors, indicating severe external metal loss.
