Case Study

NDT and Condition Assessment of Strategic Crossing

Advanced Engineering Solutions (AES) were commissioned to inspect three ageing, operationally critical, potable water mains at a strategic crossing location. This pipe bridge inspection was part of a wider fitness for purpose assessment of the 40 km long pipelines. Which also included a review of historic assessment work conducted over a 20 year period. The below pictures show the pipe crossing, erected scaffold for access and AES's MFL tool being implemented on one of the mains. The main is constructed of steel spools along the crossing and cast iron bends at each embankment. AES were tasked with providing a detailed assessment of the mains condition, fitness for purpose and to provide remaining asset lives.

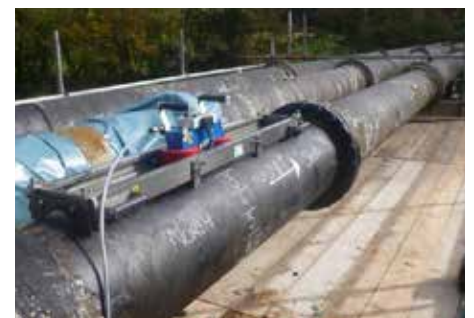
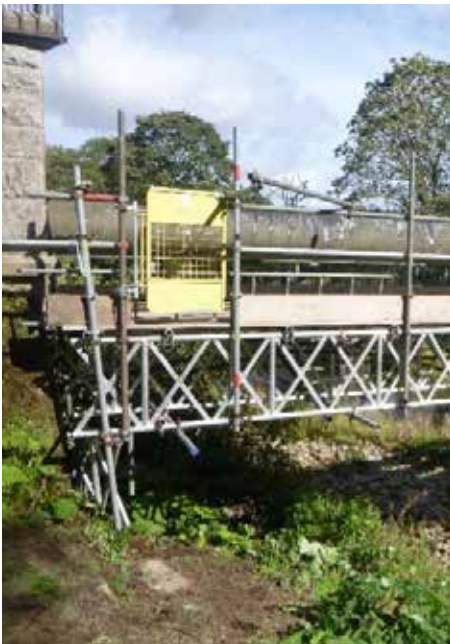
A visual survey of the external coating, joints, flanges, supports, and restraints were also carried out with the condition of each being recorded.

On completion of the site works, AES reinstated the external coating using a Denso Clad type wrap system to which AES are approved applicators.
